Nonlinear dynamic behaviour of severely corroded reinforced concrete columns: shaking table study

Xiao Ge¹ · Matthew S. Dietz¹ · Nicholas A. Alexander¹ · Mohammad M. Kashani²

Received: 13 June 2019 / Accepted: 1 November 2019 / Published online: 8 November 2019
© The Author(s) 2019

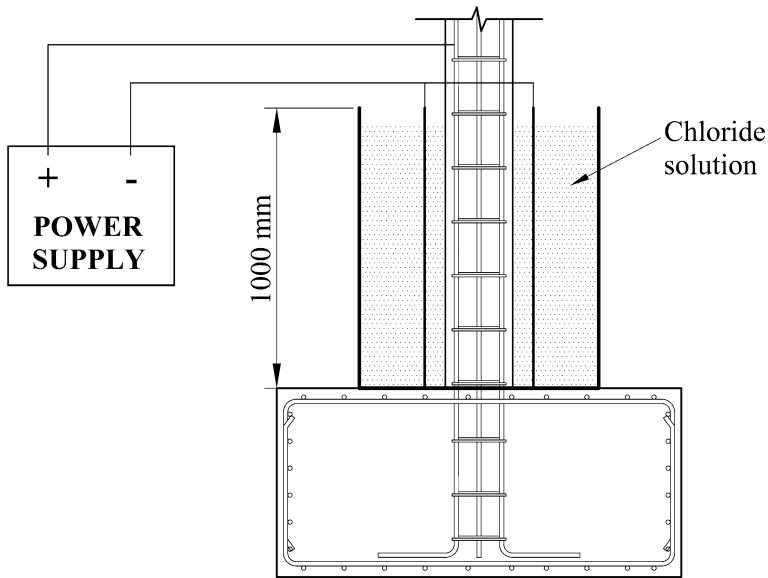
Fig. 2 Accelerated corrosion procedure setup

A polyethene pipe with 500 mm diameter and 1000 mm height was mounted on the top of the foundation to create a bath for the sodium chloride solution. Four 250 mm × 1000 mm stainless plates are connected around the column as the cathode. Reinforcing bars and stainless plates are connected to the power supply by cables respectively. The sodium chloride solution contained 10% sodium chloride (i.e. salt). It is worth clarifying that no additional load (other than its own weight) is applied on the specimens during the procedure. The ACP setup is shown in Fig. 2.

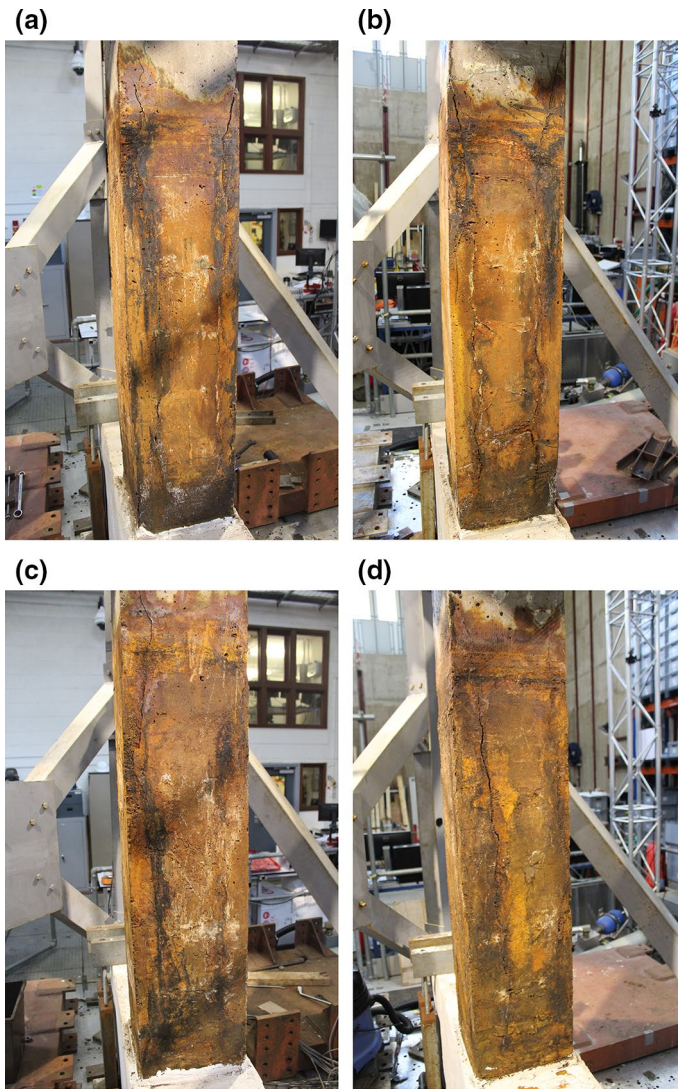
Fig. 3 Corrosion-induced cracks in Corr1 and Corr2 specimens: **a, b** front and back of Corr1, and **c, d** front and back of Corr2

where Q refers to total electric charge, M refers to the molar mass of the anode (55.847 g for Fe), z is the ionic charge (2 electrons per Fe^{2+} in this case), I is the measured current of the circuit and T is the duration of corroding process. The ACP took 3 and 6 months for the Corr1 and the Corr2 specimens, respectively. During this period, the average measured currents are 1.39A (Corr1) and 1.37A (Corr2). Figure 3 shows the corrosion-induced damage to the RC columns after ACP. The horizontal and vertical cracks can be observed. This

is because of the volumetric expansion of corrosion product resulting in internal pressure, which subsequently causes the concrete cover to crack along the reinforcement.

This is because the additional corrosion in the corner bars results in further corrosion-induced concrete cover cracking (as shown in Fig. 3), and hence, a significant reduction in concrete strength. Therefore, concrete cover crushes earlier on one side of the column,

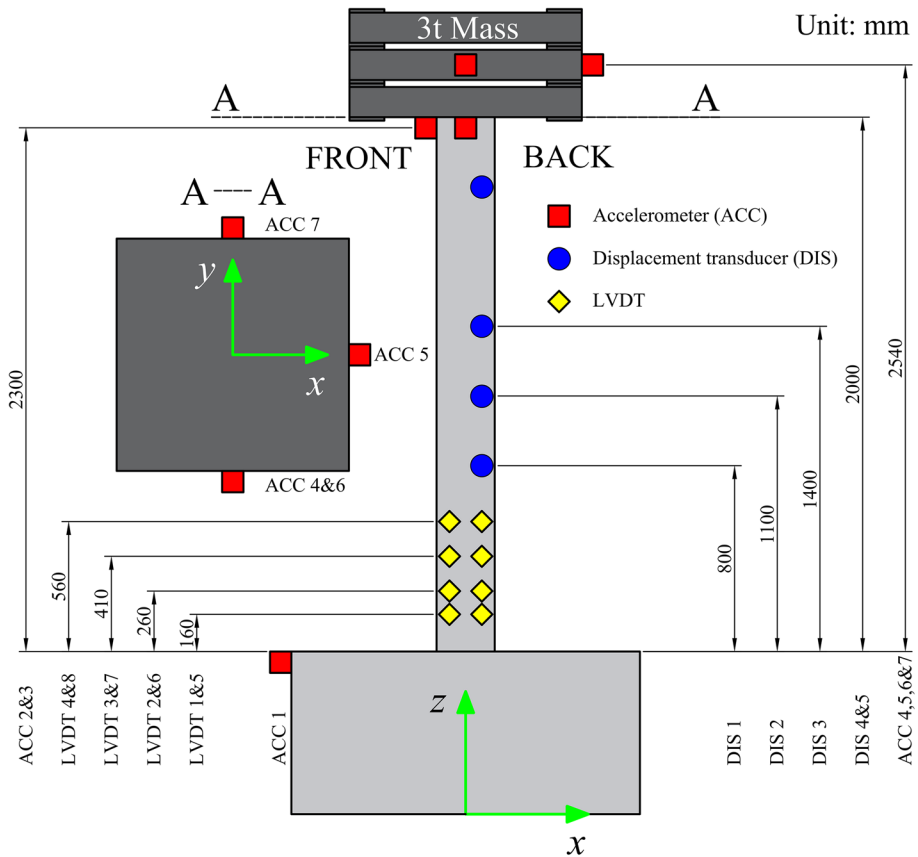
Fig. 5 Instrumentation layout

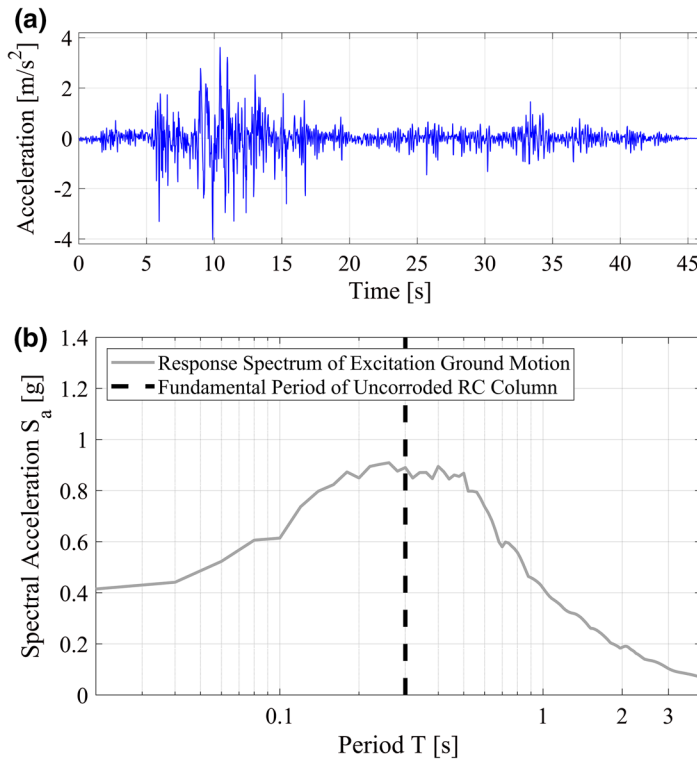
Fig. 6 Spectrally matched Manjil earthquake ground motion record: **a** acceleration time-series, and **b** elastic total acceleration response spectrum

The ground motion used in this study is selected from a set of ground motions taken from FEMA P695 (2009), which were previously used in a numerical exploration study (Kashani et al. 2017b). The spectrally matched Manjil earthquake (1990) is displayed in Fig. 6a [the ground motion is spectrally matched to mean response spectrum of all FF ground motions listed in FEMA P695 (2009)]. Figure 6b shows the response spectrum of the excitation ground motion together with the fundamental period of the UnCorr test specimen. Since the period of the tests specimen is within the maximum response spectrum of the proposed ground motion, there is no need to time-scale the ground motion (i.e. reducing the ground motion duration).

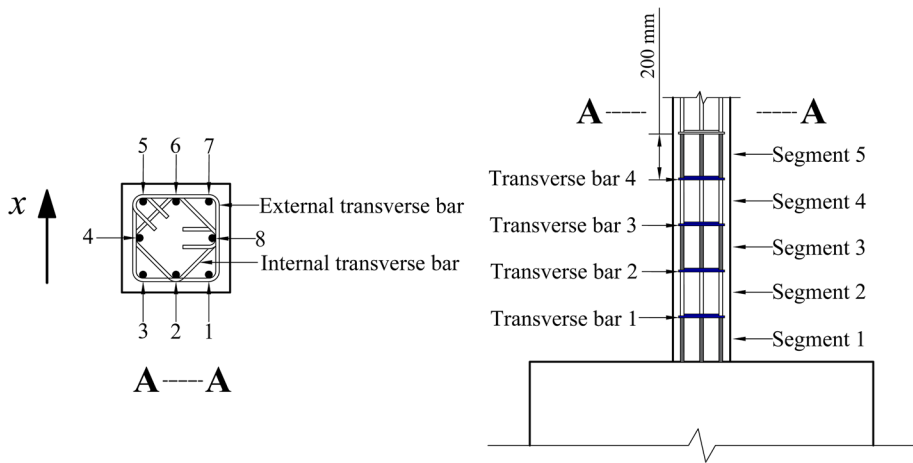
Fig. 7 Physical segments to investigate the spatial variability of corrosion

Figure 8 indicates clearly that the mass loss in the corner bars (bars 1, 3, 5 and 7 in Fig. 7) is larger than mid-face bars (bars 2, 4, 6 and 8 in Fig. 7). This is because the corner bars are exposed to bi-directional chloride diffusion, while the mid-face bars are exposed to unidirectional chloride diffusion. The synergistic effect of two-sided chloride ingress accelerates the corroding process, which leads to more deterioration and even earlier failure of the corner bars. This phenomenon is reported by other researchers (Lee et al. 2003; Khan et al. 2017). Zhang et al. (2011) conducted an experiment on fly ash concrete with two and three-dimensional chloride ingress. This finding is consistent with those summarised by Zhang et al. (2011).

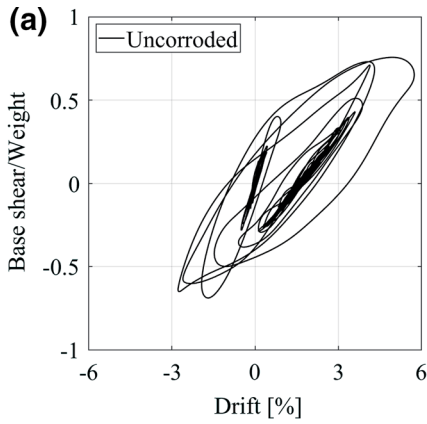
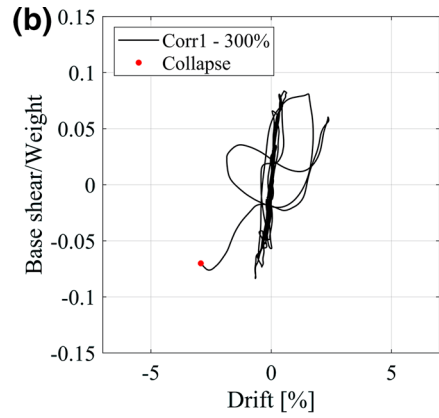
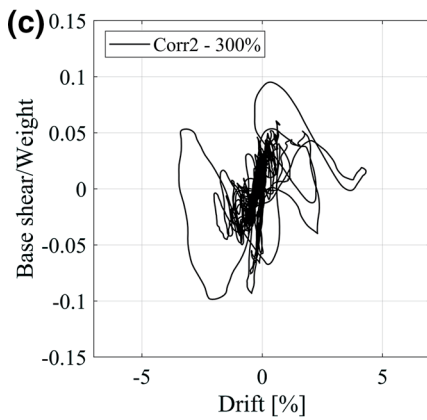
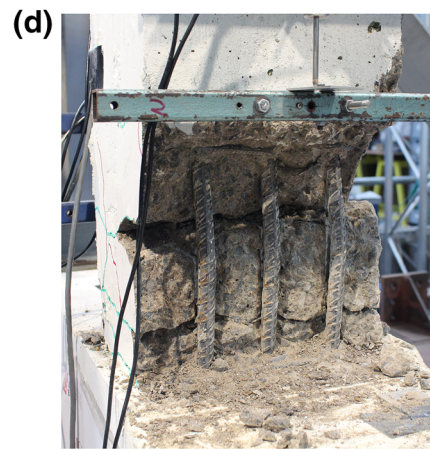
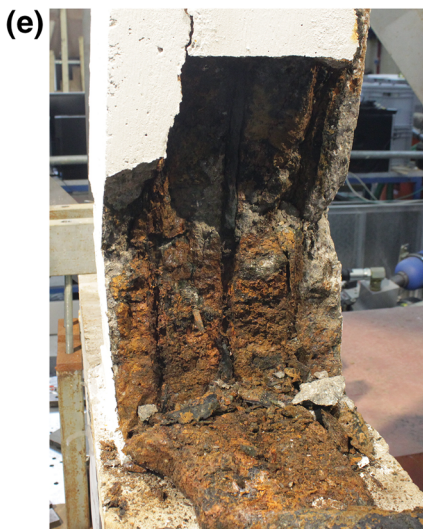
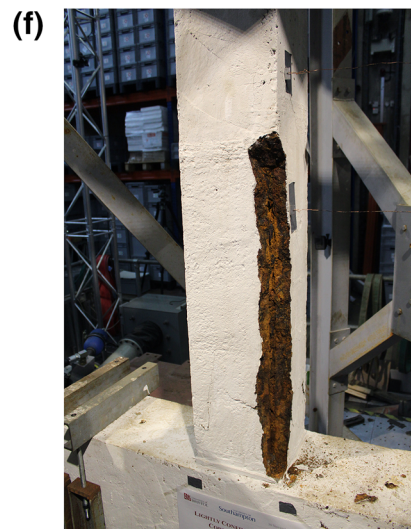
Fig. 11 Force-displacement hysteretic response and observed damage of all three columns at 300% excitation (extensive damage): **a** hysteretic response of UnCorr, **b** hysteretic response of Corr1, **c** hysteretic response of Corr2, **d** observed damage in UnCorr, **e** observed damage in Corr1, and **f** observed damage in Corr2

Figure 11 shows the force–displacement response of all three columns together with observed visual damage on tests specimen at this 300% excitation level. Figure 11a shows that the Corr1 column collapses completely at the time of 10 s. About 90% of lateral strength reduction is observed compared with the UnCorr control specimen. The Corr2 column (Fig. 11b), despite a slightly higher corrosion level (in terms of mass loss),

experiences severe damage without a complete collapse. Note that the mass loss measurements are averaged over 200 mm length of rebar. Therefore, it does not directly reflect the highly localised weakest point of the corroded RC columns. The spatial variability of

The force–displacement response of the Corr2 column at 300% does not show the typical hysteretic response of RC components such as Lehman et al. (2004) and Kashani et al. (2019). During the test, at 300% excitation, some of the vertical bars fractured (due to a combination of pitting corrosion, tensile strain level, and low-cycle fatigue). Therefore, the response of Corr2 does not show the hysteretic response of a typical RC column. It was observed that the column was pivoting between the edges similar to a rocking column, and hence, resulting in concrete crushing in compression. In the hysteretic rocking response (Fig. 11c), force increases without an increase in displacement until it rocks, and as soon as the joint opens force significantly drops; i.e. negative stiffness (Makris and Vassiliou 2014). A rocking column system is typically characterised by a linear negative slope (negative tangent stiffness) of the force–deflection response (during the rocking phase). This negative tangent stiffness is observed in Fig. 11c in the high amplitude loops (for positive displacements). Furthermore, Fig. 11c shows that the hysteretic response is not symmetrical, which is due to a single-sided opening rocking which contains both in-plane and out-of-plane components. Figure 11d shows the observed damage in the UnCorr column, which is mainly due to inelastic buckling of vertical bars and premature crushing of core concrete. Figure 11e, f shows the observed damage in Corr1 and Corr2 columns. Figure 11e shows that the complete collapse of Corr1 column is due to a severe loss of vertical reinforcement due to corrosion as well as corrosion-induced damage to the surrounding concrete. Figure 11f shows that the damage in Corr2 column is mainly at one side of the column, which justifies the unsymmetrical hysteretic response in Fig. 11c.

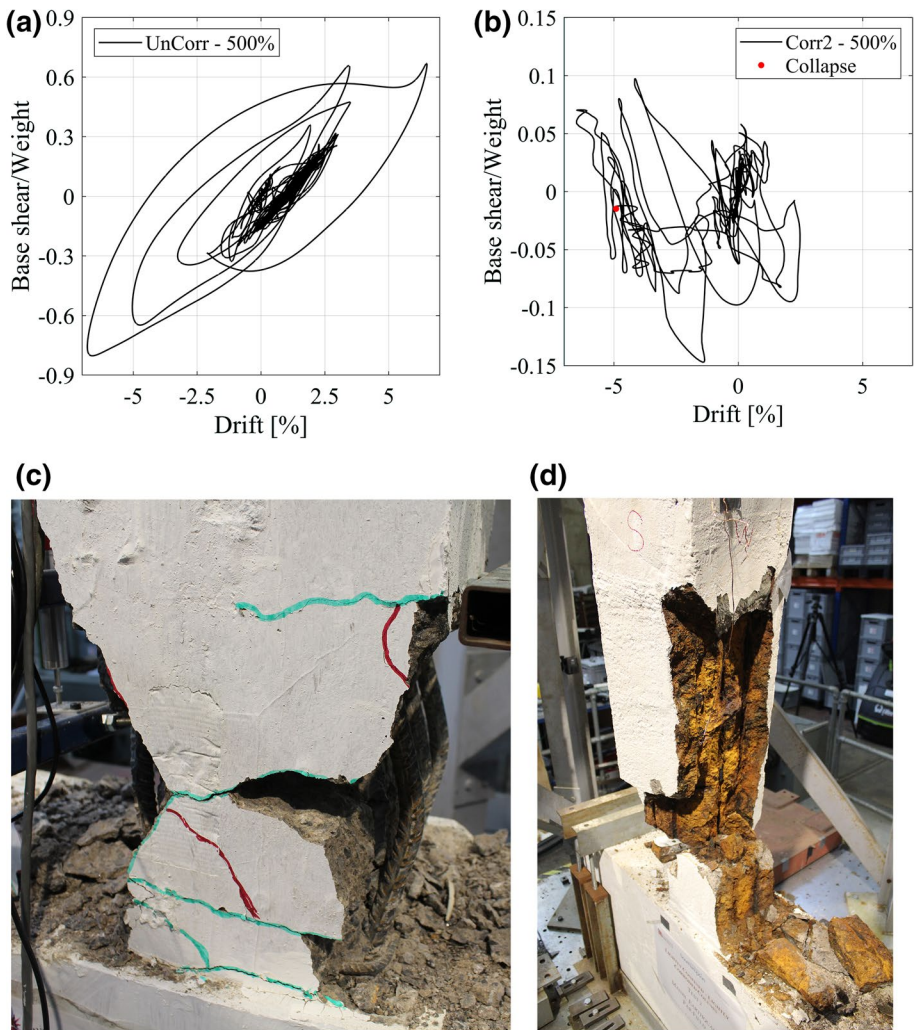
Fig. 12 Force-displacement hysteretic response and observed damage of UnCorr and Corr2 columns at 500% excitation (complete damage): **a** hysteretic response of UnCorr, **b** hysteretic response of Corr2, **c** observed damage in UnCorr, and **d** observed damage in Corr2

Figure 12 shows the force–displacement response of UnCorr and Corr2 columns (the Corr1 column collapsed at 300% excitation) together with observed visual damage on tests specimen at 500% excitation level. Figure 12a shows the force–displacement response of the UnCorr level at the 500% excitation level. The hysteretic response shows severe cyclic degradation, which is due to the inelastic buckling and low-cycle fatigue of vertical reinforcement. Figure 12b shows that at the 500%, the Corr2 column exhibits an erratic force–displacement response, which includes an increasing residual tilting until the complete collapse at a time of 13 s. 80% lateral strength reduction is observed compared with the UnCorr control specimen. This is before it is subjected to the largest-amplitude pulse of the ground motion. Figure 12c shows the observed damage in UnCorr column after the 500% excitation. The visual inspection of damage indicates that severe buckling of vertical bars in lightly confined columns which resulted in the premature crushing of core concrete previously at 300% excitation level results in severe buckling and large residual drift in the UnCorr column after the experiment. This consequently results in severe degradation in the hysteretic response of the column. Figure 12d shows the completely collapsed Corr2 column at 500% excitation, which shows the unsymmetrical failure of the column. This is due to the unsymmetrical corrosion of vertical bars.

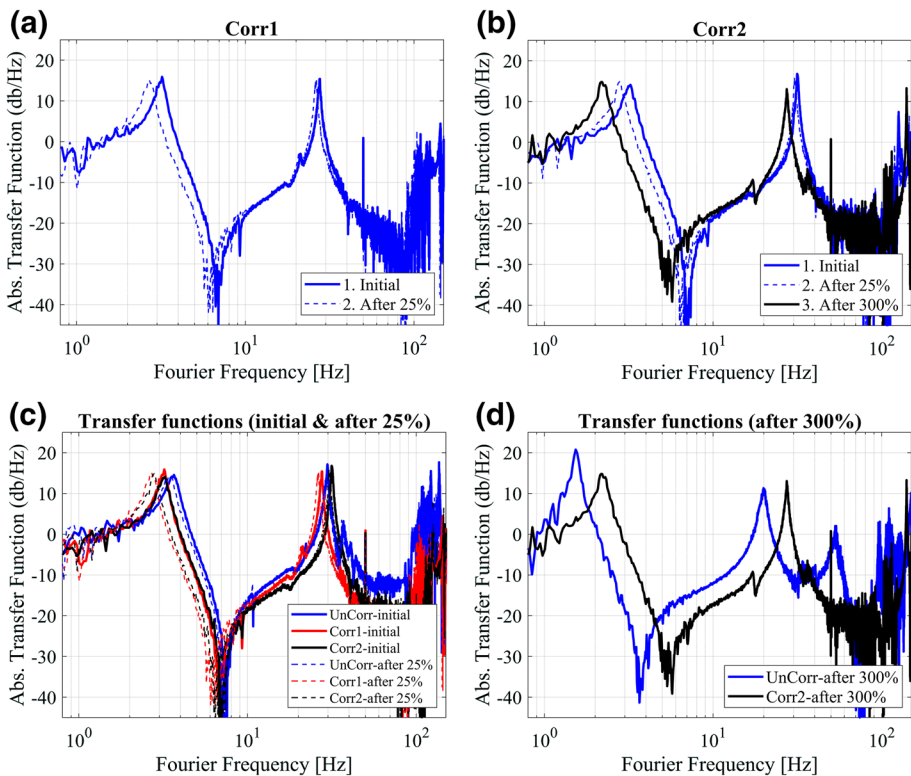
Fig. 14 Transfer function estimate of test specimens using the low-amplitude white noise excitation: **a** Corr1, **b** Corr2, **c** all three columns, and **d** UnCorr and Corr2 after 300% excitation

Power Spectral Density (PSD) of structural time-history records can extract structural characteristics in the frequency-domain (Cryer and Chan 2008). The transfer function (based on input and structural response accelerations time-series) are estimated using a MATLAB (1994–2018) toolbox (Vold et al. 1984), which employs Welch's algorithm (1967). Large peaks of the transfer function estimate modal frequencies. In this study, only the first and second modes are considered as shown in Fig. 14. Since the Corr1 specimen collapsed at 300% excitation, the white-noise tests data are not available at and beyond 300% excitation for this column.

with low levels of damage. However, in this case (Corr2 after 300% of PGA) we have a critically damaged column whose system characteristics are very sensitive to response amplitude levels. Therefore, if the aim is to characterise the extent of damage of a highly corroded/damaged system, then in situ ambient (low amplitude) system identification tests can produce ambiguous results that are suggestive of smaller damage than is actually present.
